Coal Mine Fatal Accident 2005-16

Operator:	Enterprise Mining Company, LLC
Mine:	Mine #1
Accident Date:	November 4, 2005
Classification:	Electrical
Location:	Dist. 6, Letcher County, Kentucky
Mine Type:	Underground Mine
Production:	2,000 tons coal/day

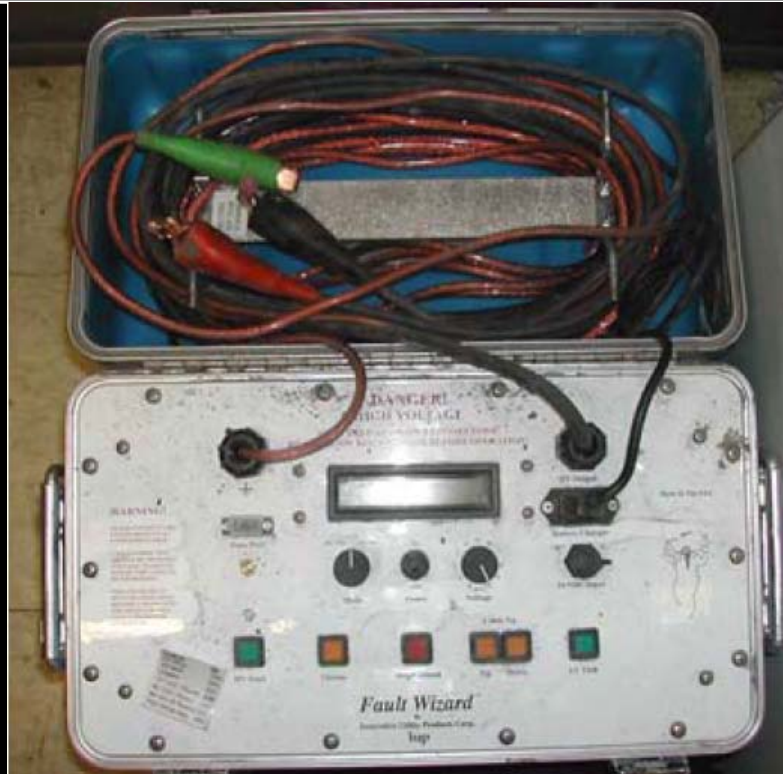
The circuit breaker protecting the continuous mining machine tripped due to a fault in the trailing cable. The victim and another electrician began the process of locating the fault using a high potential cable tester that was not involved in the accident.

After approximately one and one-half hours of troubleshooting without isolating the fault, the other electrician made arrangements to have the Fault Wizard™ high potential cable tester delivered to the mine. At the time, the tester was located at another mine operated by the company.

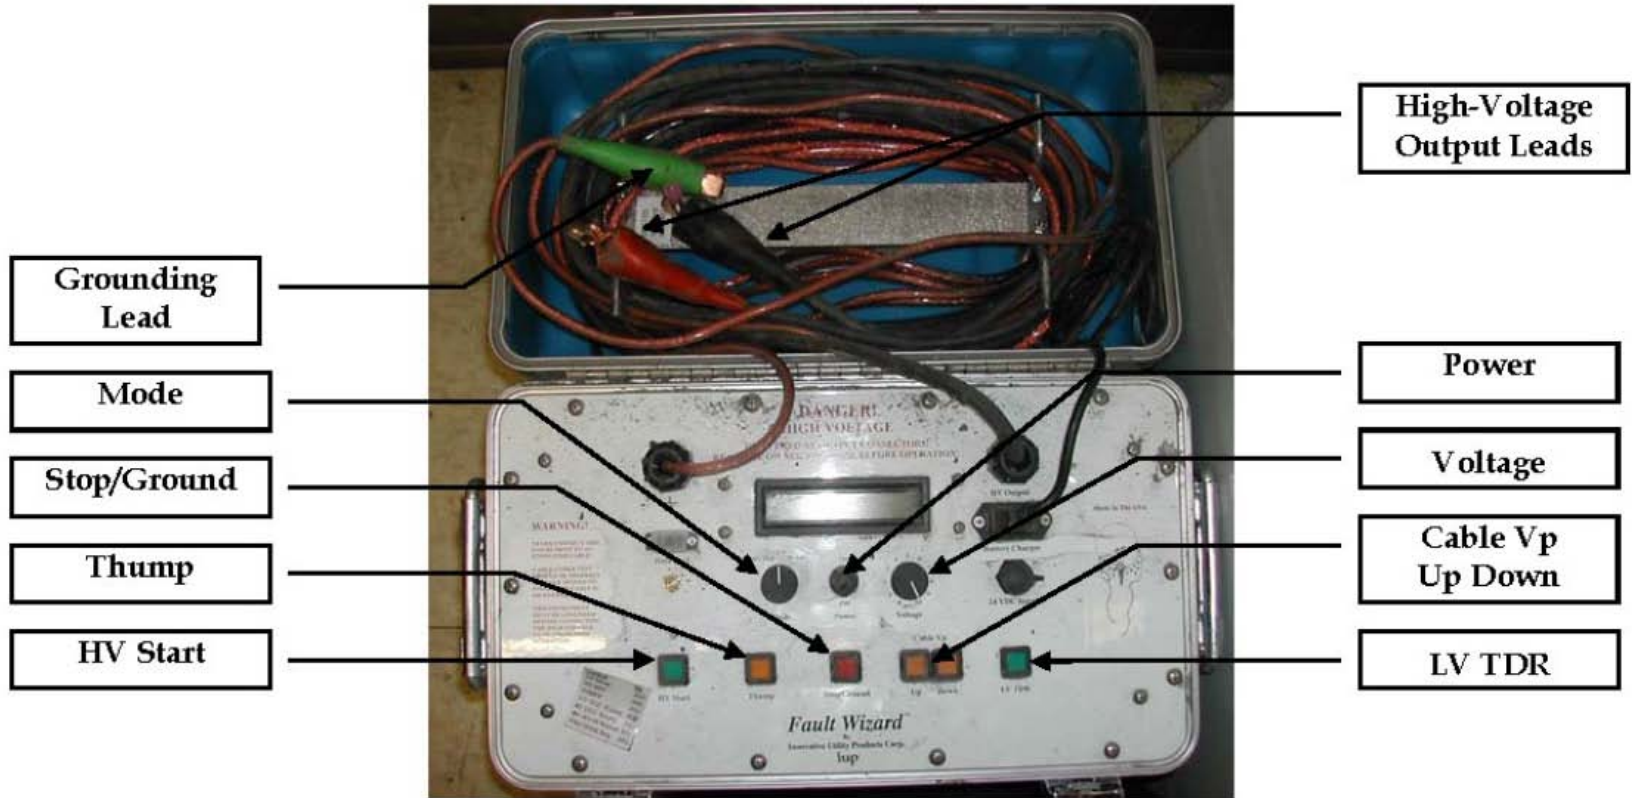
The tester was not plugged into the electrical outlet in the office. The alligator clip for the grounding cord was lying on the left side of the lid and was unattached. The alligator clip for the black high-voltage output lead was attached to the metallic shorting bar, which was mounted in the lid of the unit. The alligator clip for the red high-voltage output lead was located in the right side of the lid. (It is not clear whether or not the red alligator clip was attached to the shorting bar when the lid was first opened.)

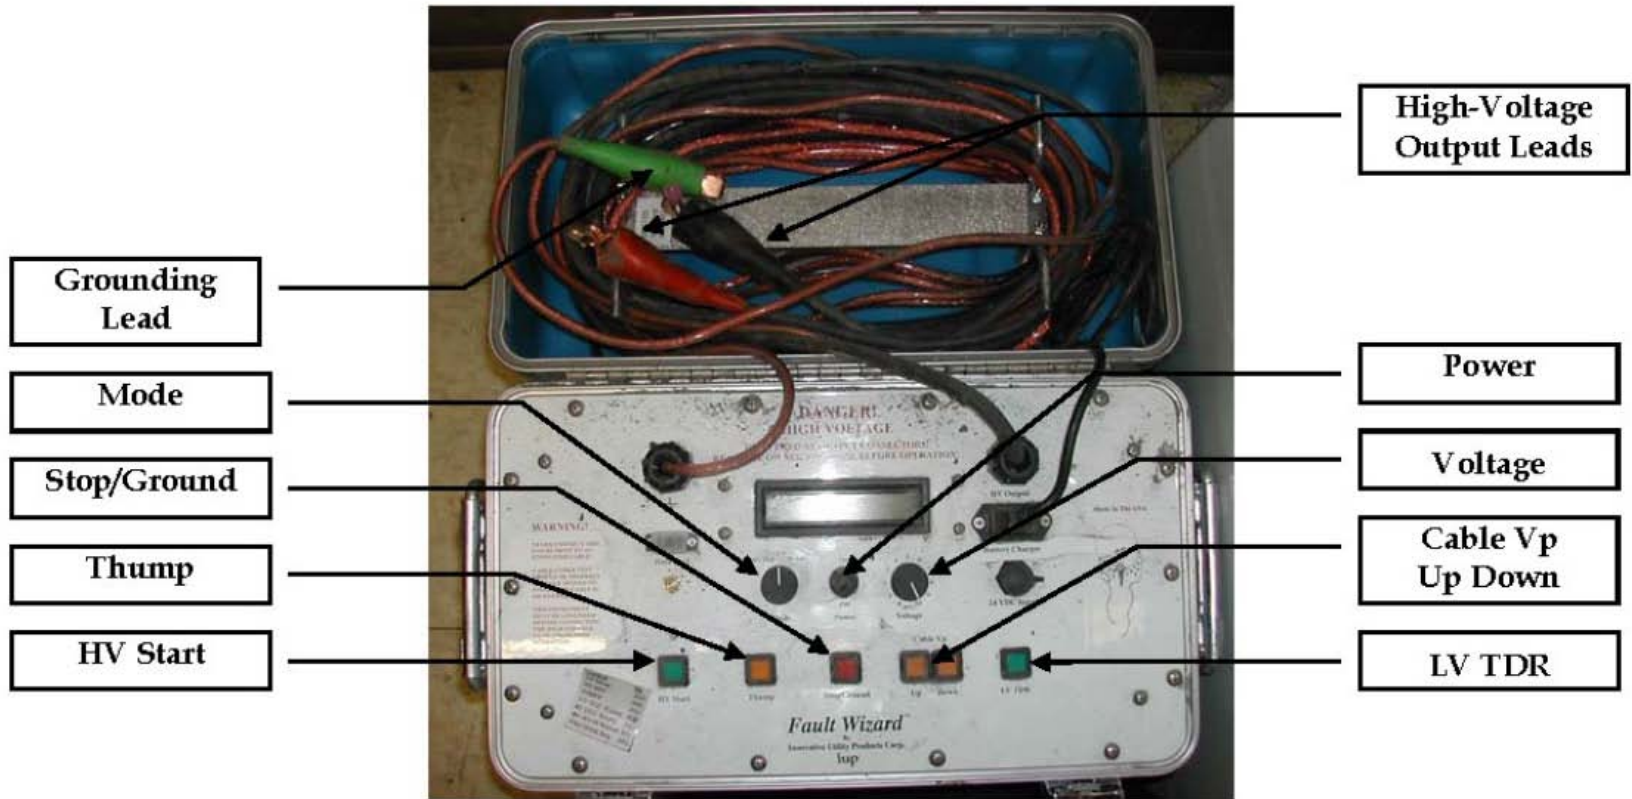
The victim turned the main power switch on and began demonstrating how to adjust the "Cable VP" setting for various sizes of mining cable. He rotated the "Voltage" control to 10KV and pressed the green "HV Start" button. An electrical arc flashed near the shorting bar mounted in the lid. A few seconds later, the victim pulled his right hand away from the tester and said "it got me". The victim attempted to stand and then collapsed on the floor.

Causal Factor: The victim was not wearing high-voltage gloves at the time of the accident.

Causal Factor: The use of high-voltage gloves was not included and demonstrated in the task training given to the victim regarding the safe use of the tester.

Causal Factor: The controls and output leads of the tester were not configured properly to allow a safe demonstration of the unit. The output leads were not connected to a suitable test cable or other load before the unit was energized in "cycle" mode.

Corrective Actions: All of the electricians employed by the company received training, given by the manufacturer's representative, on the safe operation of the tester. The electricians were instructed that the use of high-voltage gloves is mandatory while operating the unit.

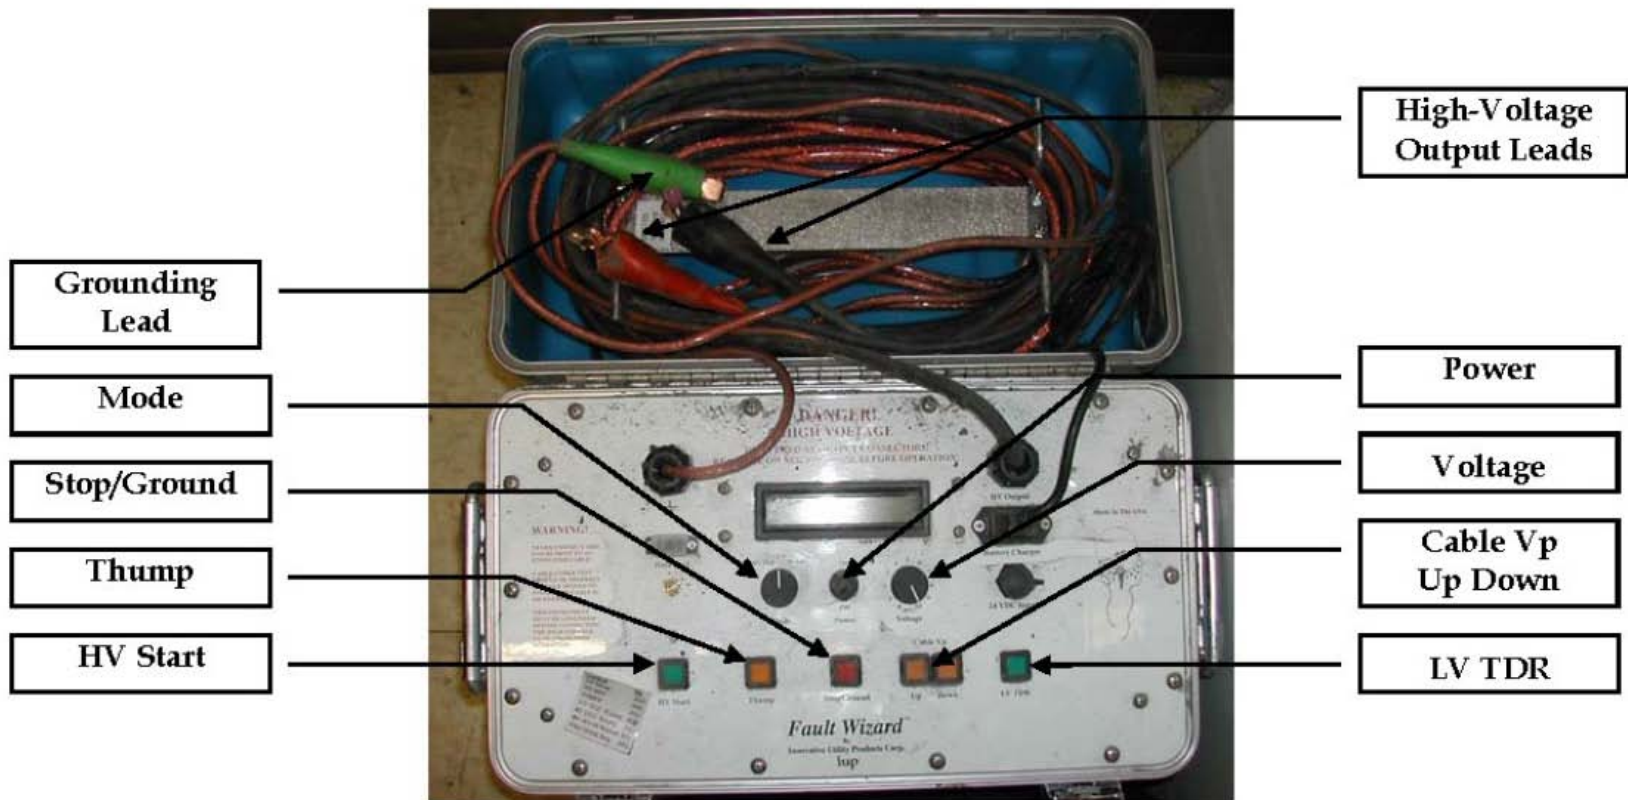
The unit is designed for four basic modes of operation. The energy state of the high-voltage output leads in each of the modes is as follows:

Cycle Mode - The capacitor is charged to the selected voltage level when the "HV Start" button is pushed. After the capacitor discharges through the output leads, the capacitor repeatedly charges and discharges with a maximum cycle time of approximately 6 seconds.

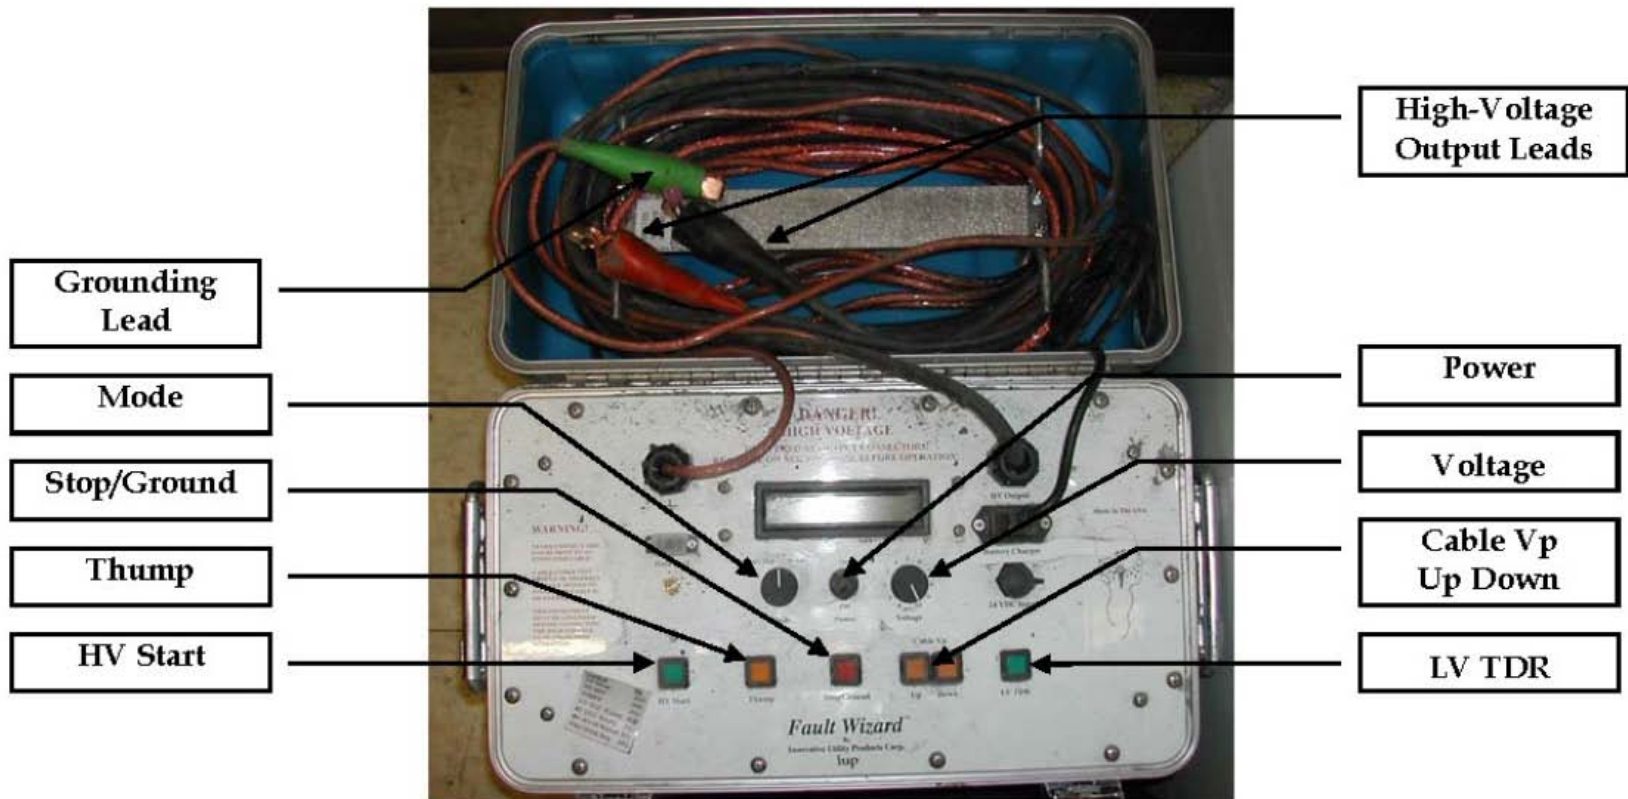
Hipot Mode - The output leads are energized when the "HV Start" button is pushed. The voltage at the output leads increases as the voltage control is rotated in the clockwise direction. The capacitor is not used in this mode. The output voltage is supplied by the high-voltage DC power supply.

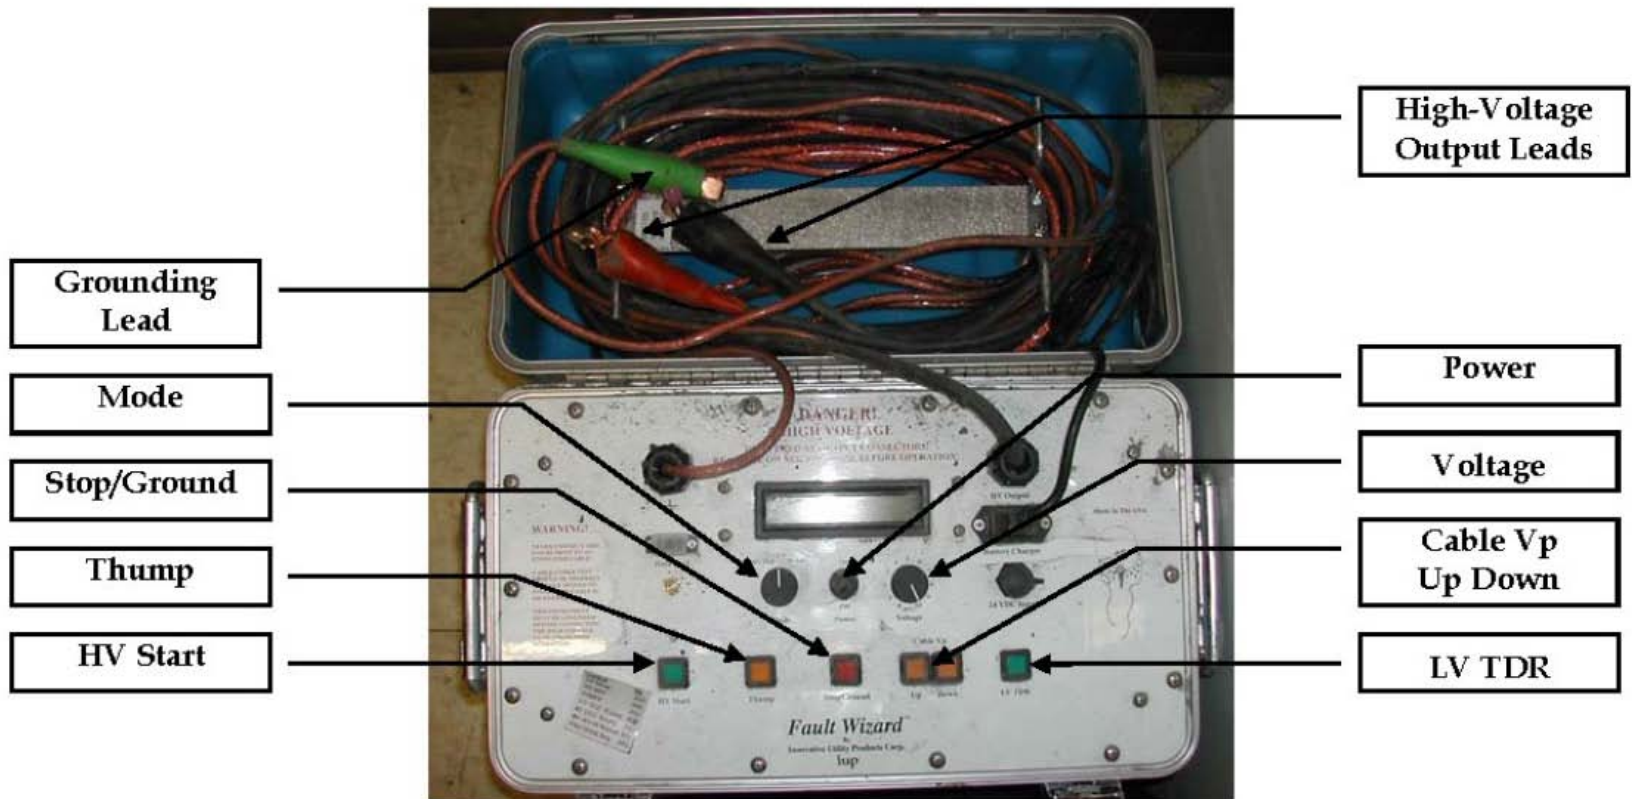
High Voltage Time Domain Reflectometry (TDR) Mode - The "HV Start" button is pushed and the capacitor charges to the selected voltage level, but the output leads are not energized until the "Thump" button is pushed. When the "Thump" button is pushed, the capacitor discharges through the output leads and a low voltage TDR pulse is simultaneously initiated.

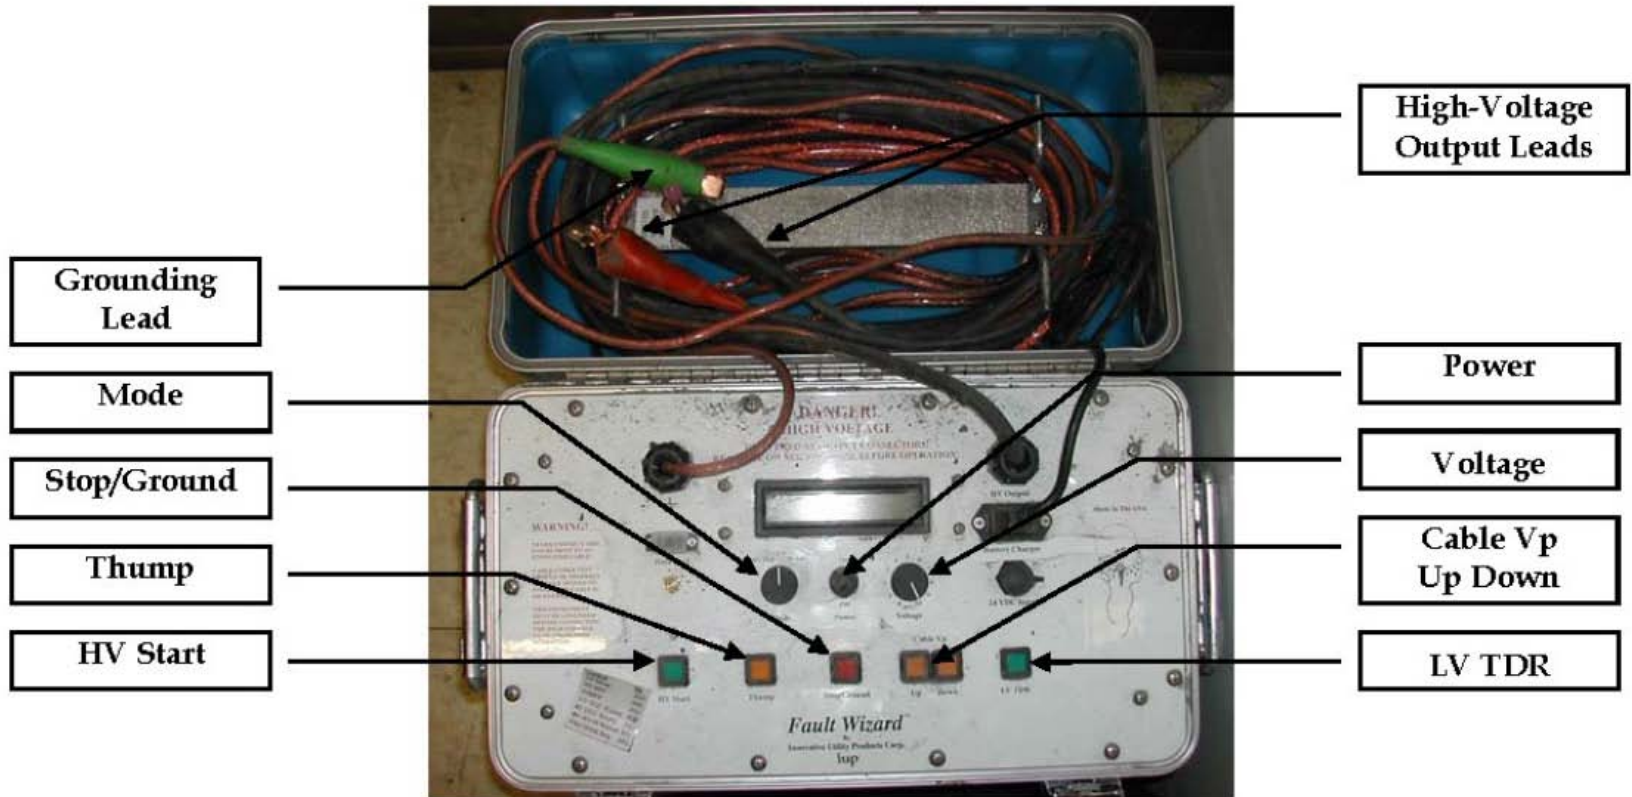
Low Voltage TDR Mode - A low voltage TDR pulse is generated when the "LV TDR" button is pushed. No high voltage discharge occurs in this mode.

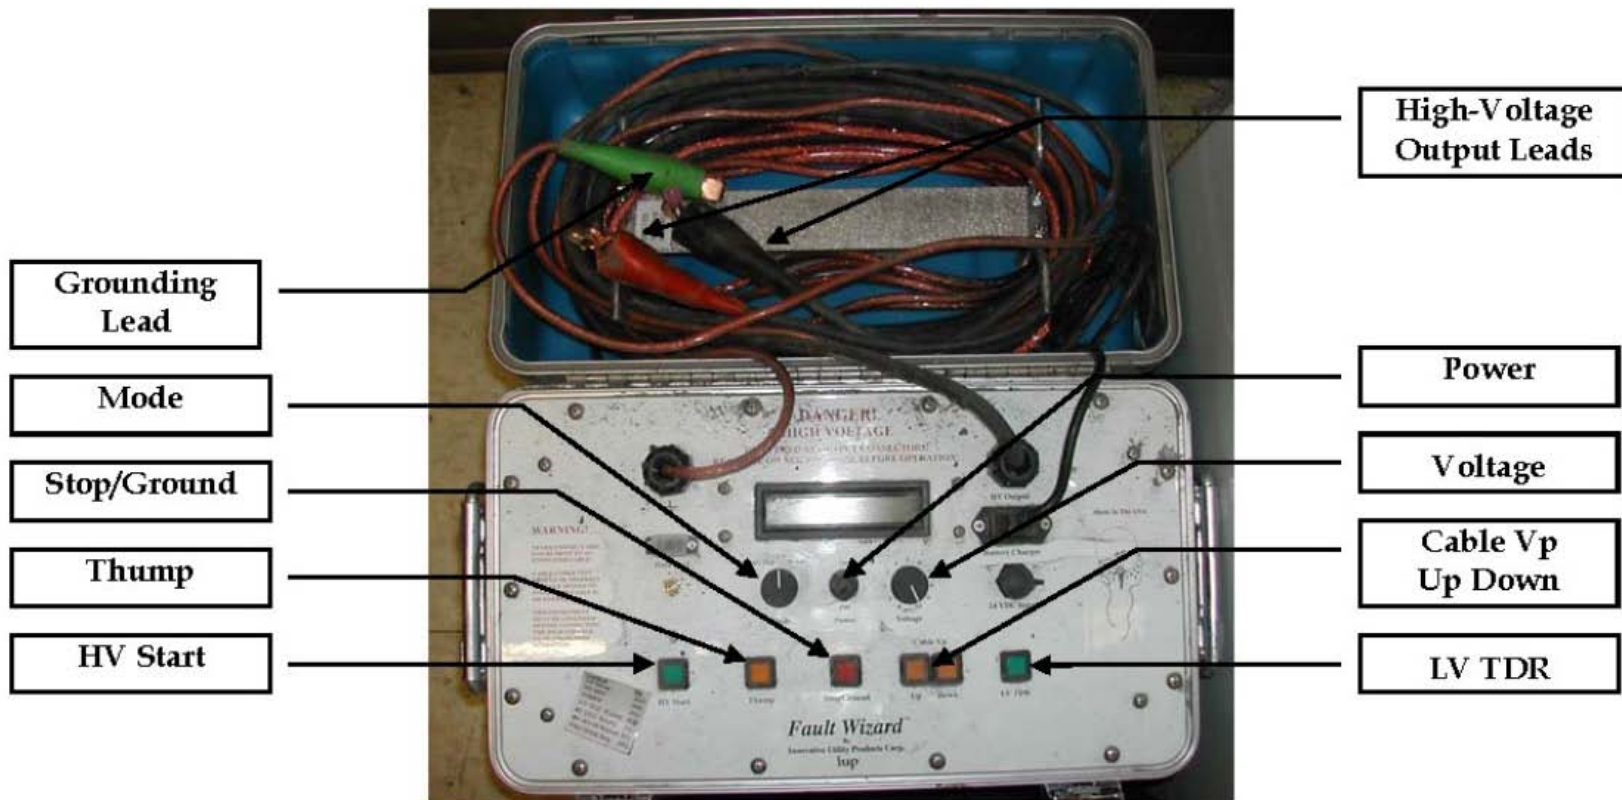
Results of Testing by MSHA Approval and Certification Center

The maximum energy available between the red test lead and any point common to the unit's frame ground was calculated as 742 Joules, which would most likely be lethal. (NFPA 70E, 2000 Edition, indicates that capacitive discharges of 50J or greater may cause ventricular fibrillation.)

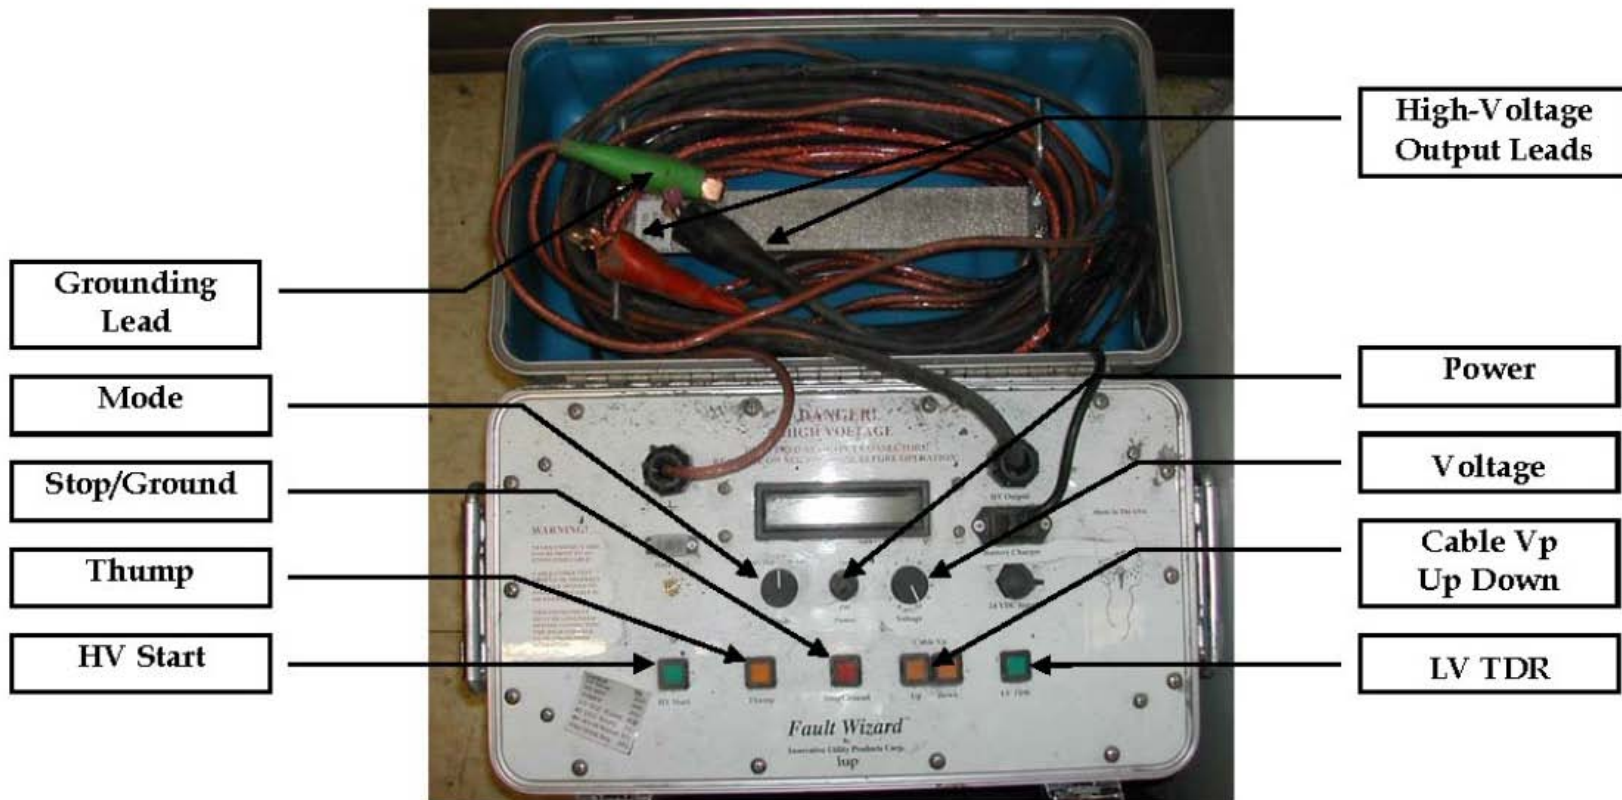
The victim attended a training session conducted on June 10, 2005, in which the operation and use of the tester were demonstrated by a local sales representative. The instructor did not wear high-voltage gloves while operating the tester, nor did he require the students to do so. Also, neither the instruction manual for the tester nor the manufacturer's demonstration video addressed the use of high-voltage gloves while operating the unit. The victim did not use the tester again in the interim period between the training and the accident.
